## **Composite Failure Analysis Handbook Update #1**

*Greg Walker*

*Boeing Defense & Space Group*

**April 1995**

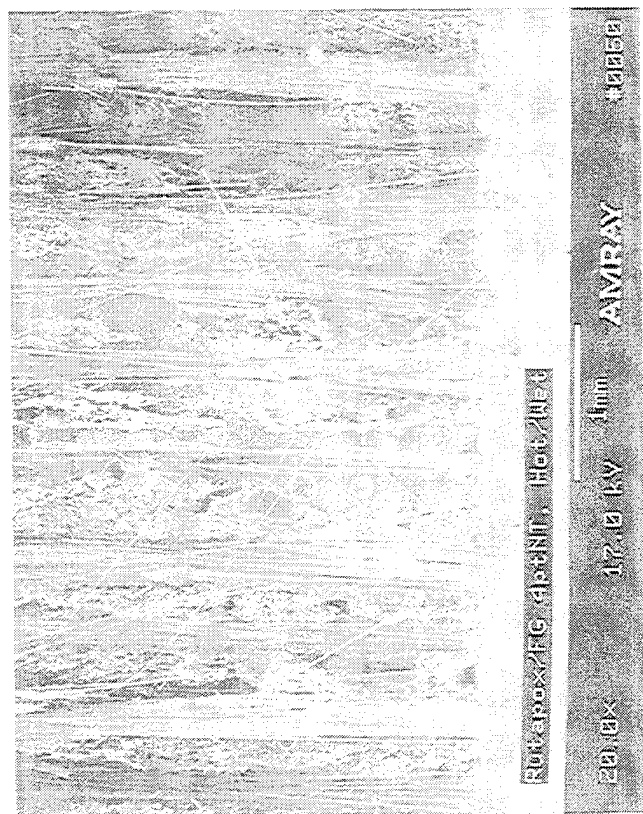
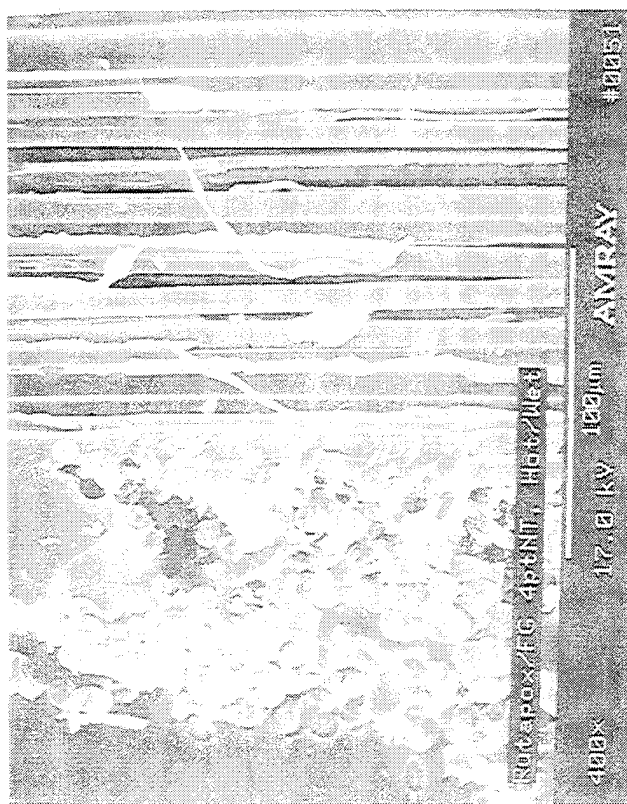
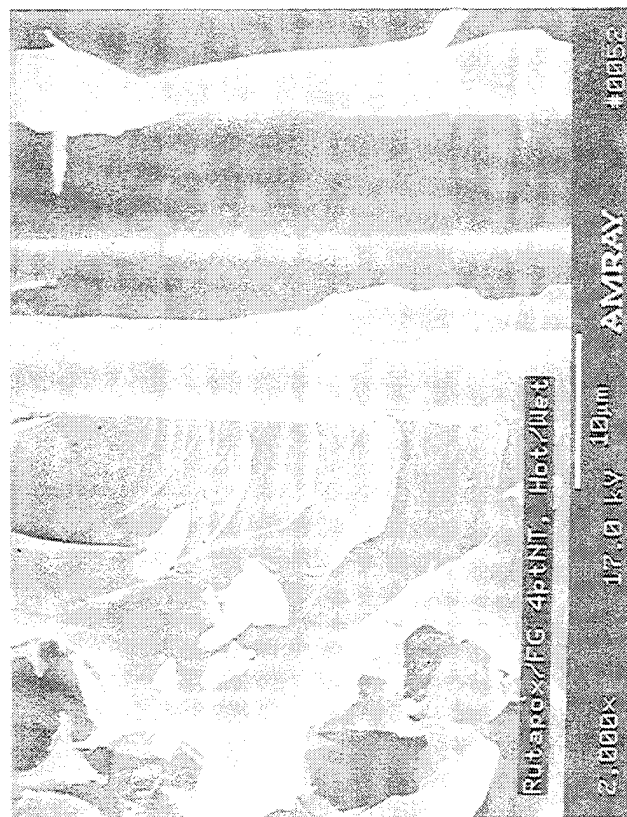
Figure 3.6-12. SEM Fractographs of a Rutapox/FG Roving 4pTNT Fracture Surface, Hot/Wet

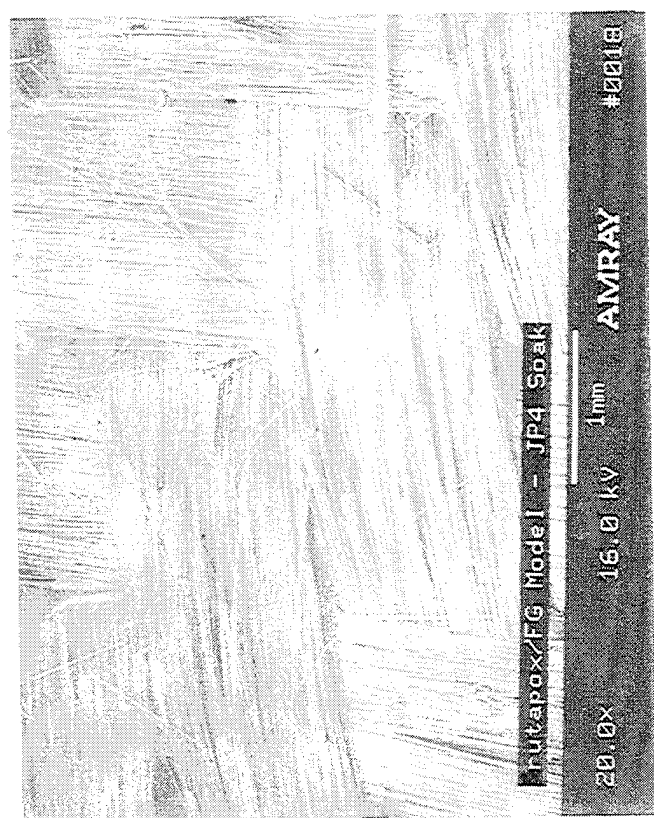
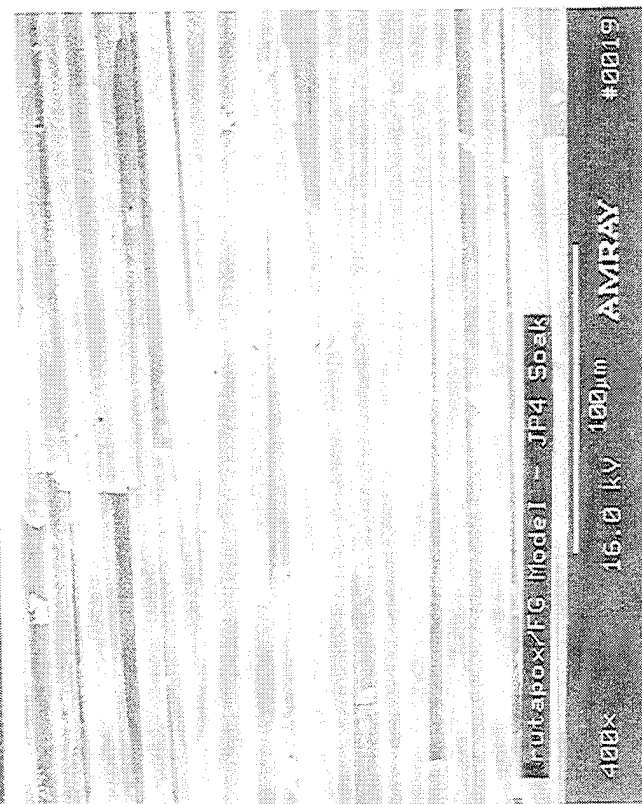
Figure 3.6-13. SEM Fractographs of a Rutapox/FG Fabric Interlaminar Mode I (Tensile) Fracture Surface Exposed to JP4 Jet Fuel for 7 days

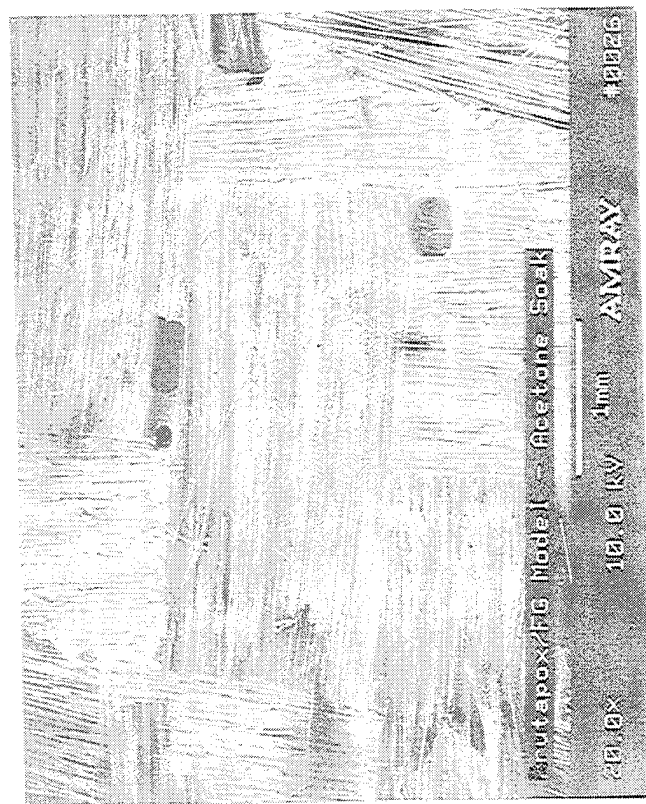
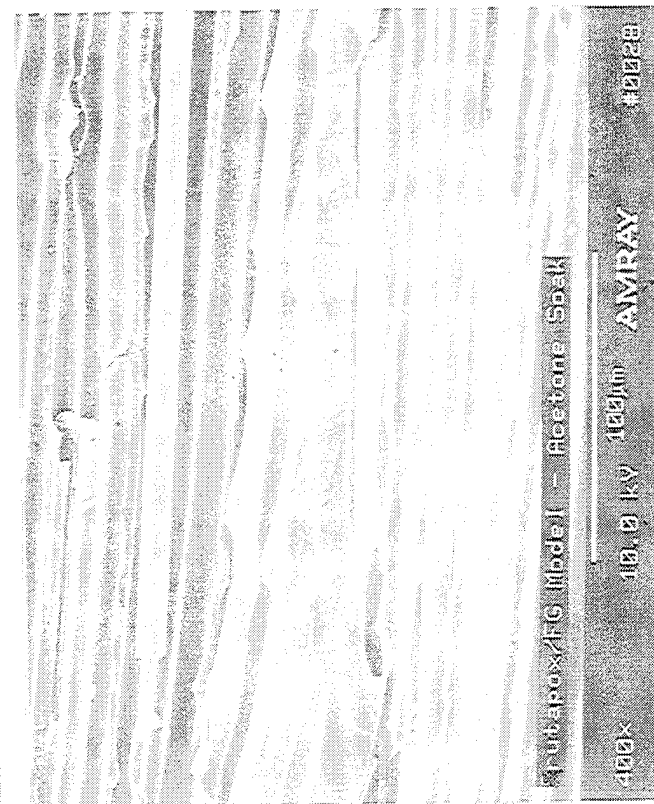
For the Rutapox epoxy resin system, only four specimens were examined that were of the most severe environments; JP4, Acetone, MEK, and Hydraulic Fluid (Figure 3.6-14 through 3.6-16). Examination of the fracture surfaces revealed no degradation of the fracture features regardless of the exposure conditions.

Figure 3.6-14. SEM Fractographs of a Rutapox/FG Fabric Interlaminar Mode I (Tensile) Fracture Surface Exposed to Acetone for 7 days

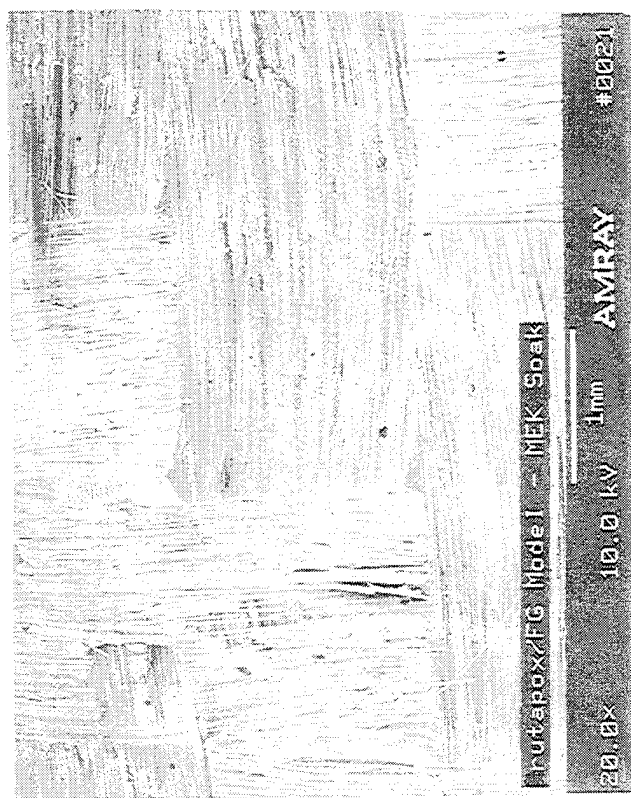
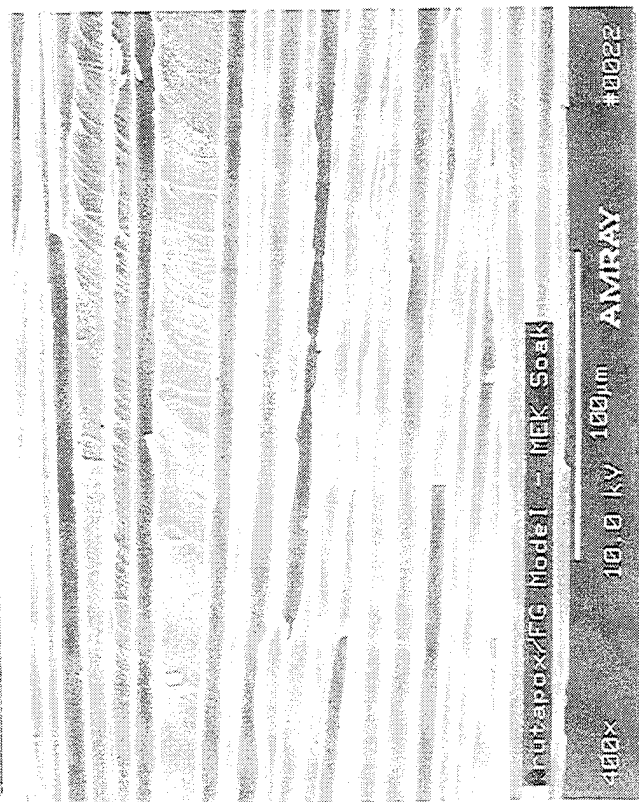
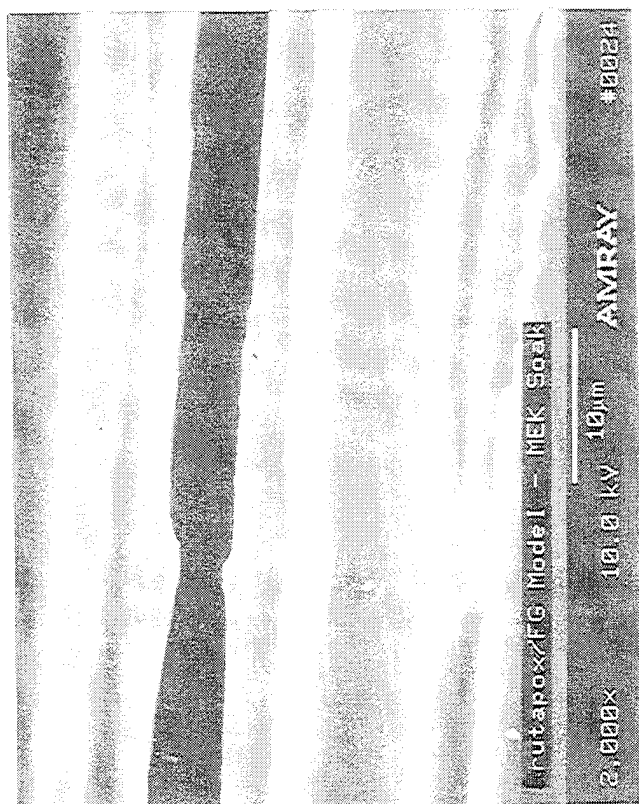
Figure 3.6-15. SEM Fractographs of a Rutapox/FG Fabric Interlaminar Mode I (Tensile) Fracture Surface Exposed to MEK for 7 days

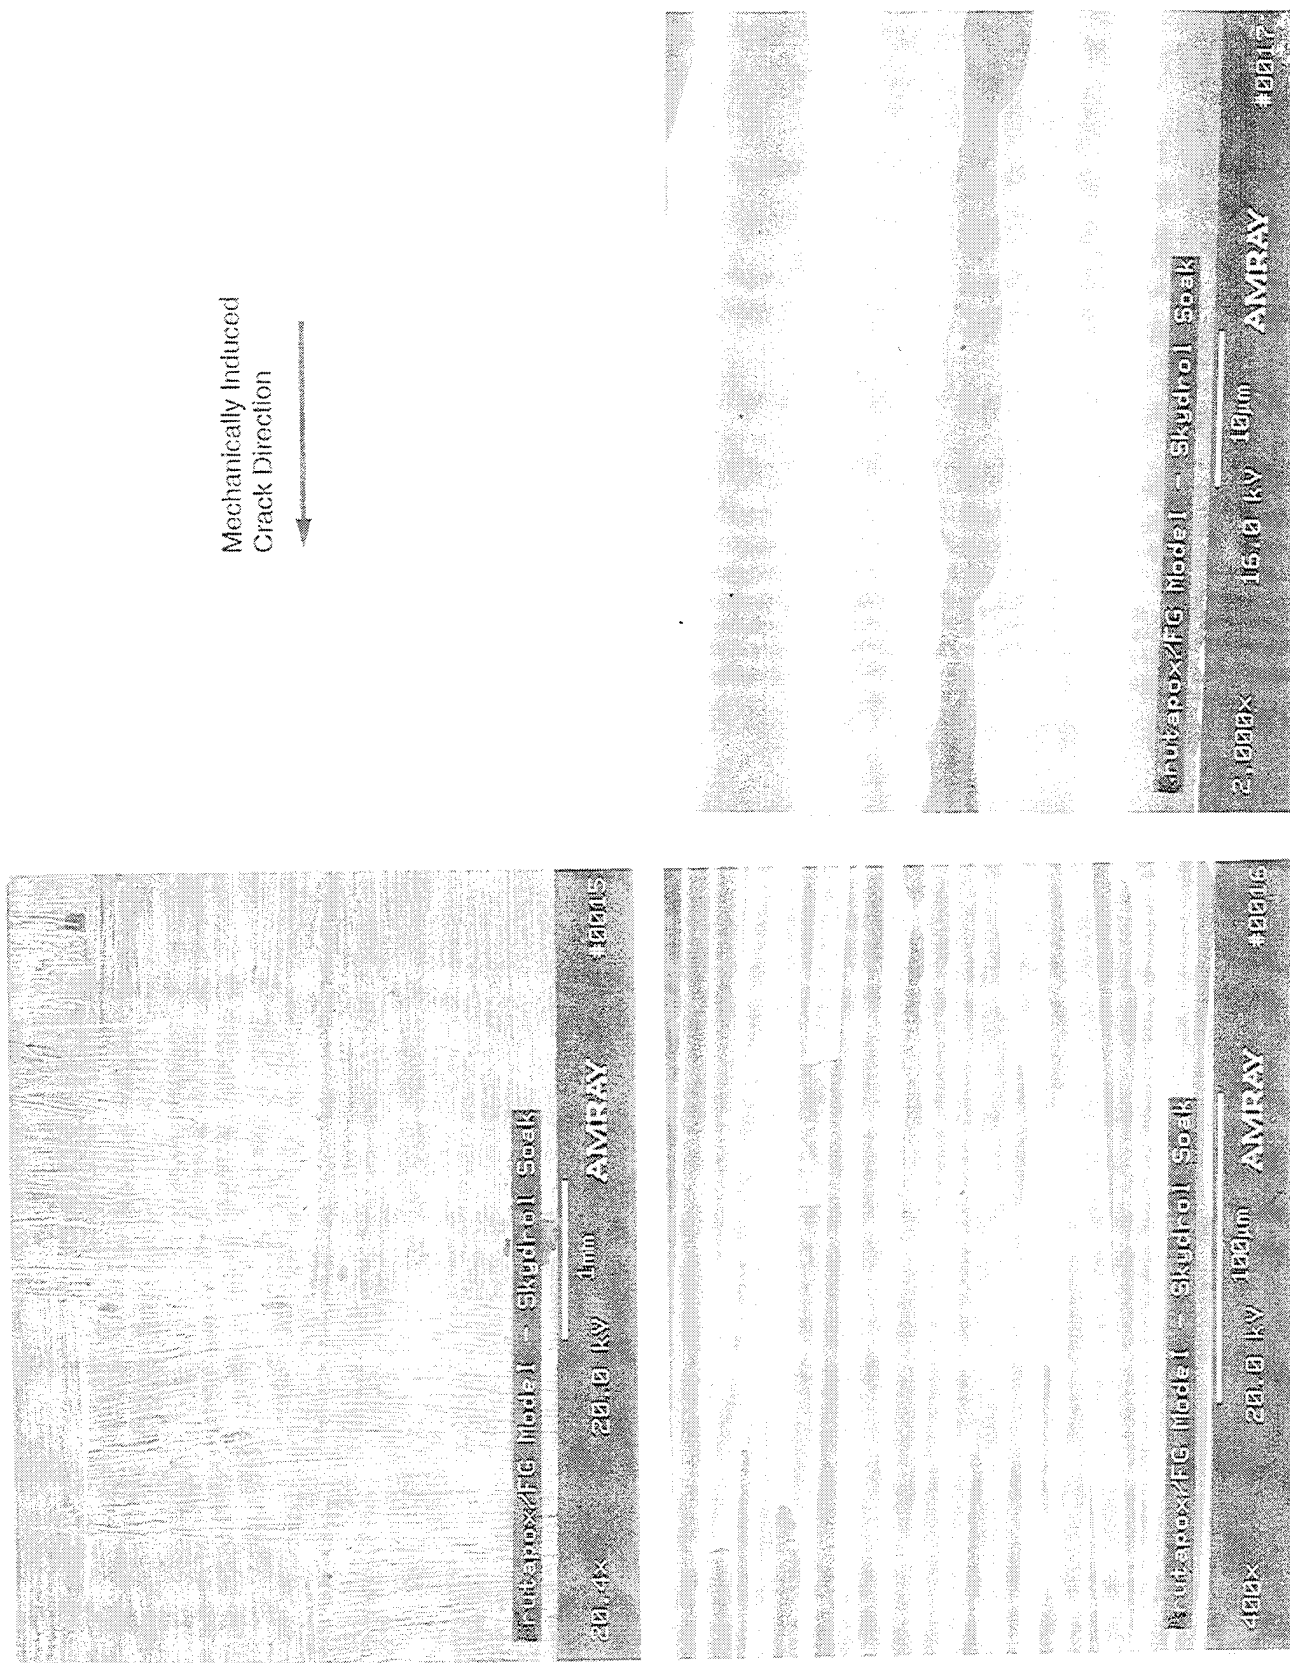
Figure 3.6-16. SEM Fractographs of a Rutapox/FG Fabric Interlaminar Mode I (Tensile) Fracture Surface Exposed to Hydraulic Fluid for 7 days

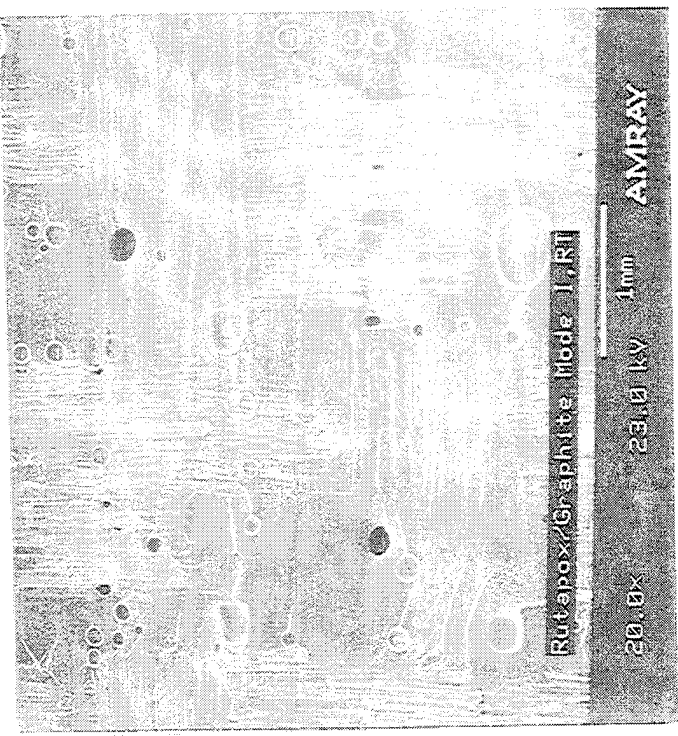
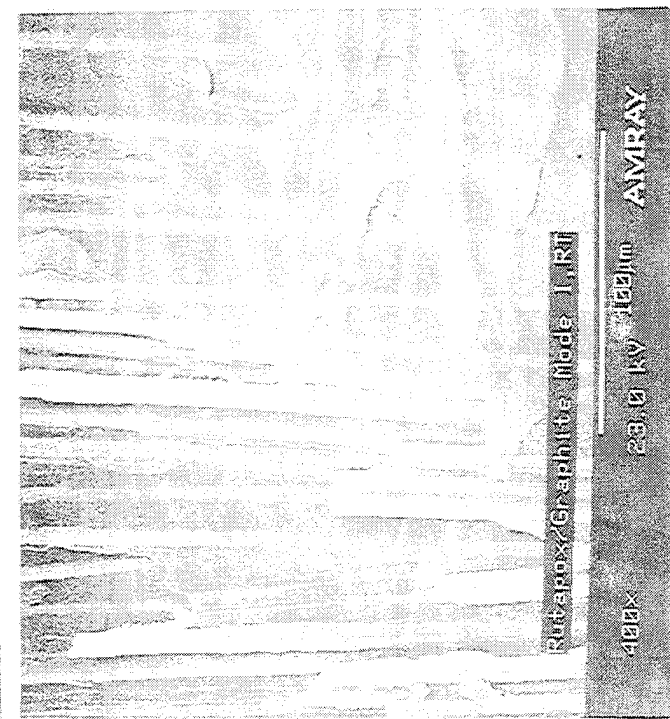
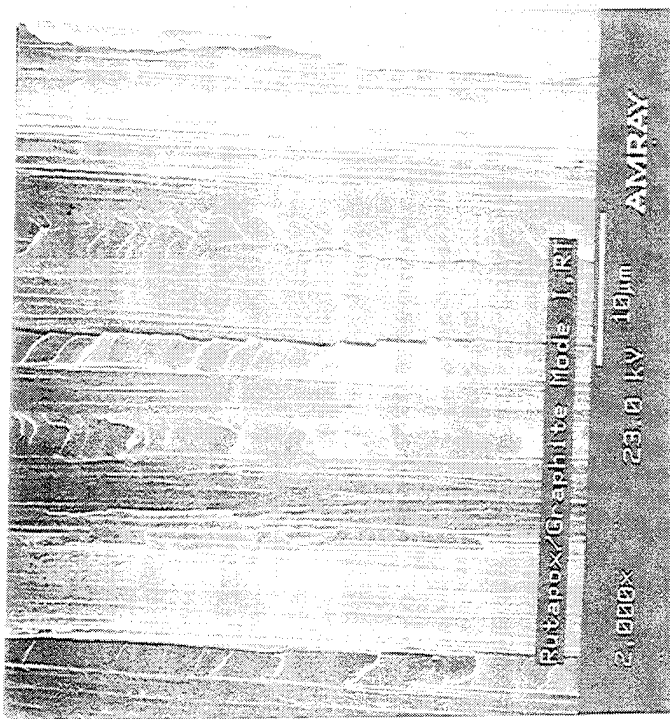
The fracture surface (Figure 3.7-1 & 3.7-2) contained numerous resin-rich regions with voids distributed throughout the surface. These voids were likely the result of panel processing rather than a specific material attribute. This resulted in an overall shiny appearance when examined visually. SEM examination (Figure 3.7-1) revealed numerous rivermarks in the resin-rich regions indicating the crack growth direction. The resin between the fibers perpendicular to the fracture direction was composed of hackles with no specific discernible fracture direction.

Figure 3.7-2. SEM Fractographs of a Rutapox/Graphite Fabric Interlaminar Mode I (Tensile) Fracture Surface, RT

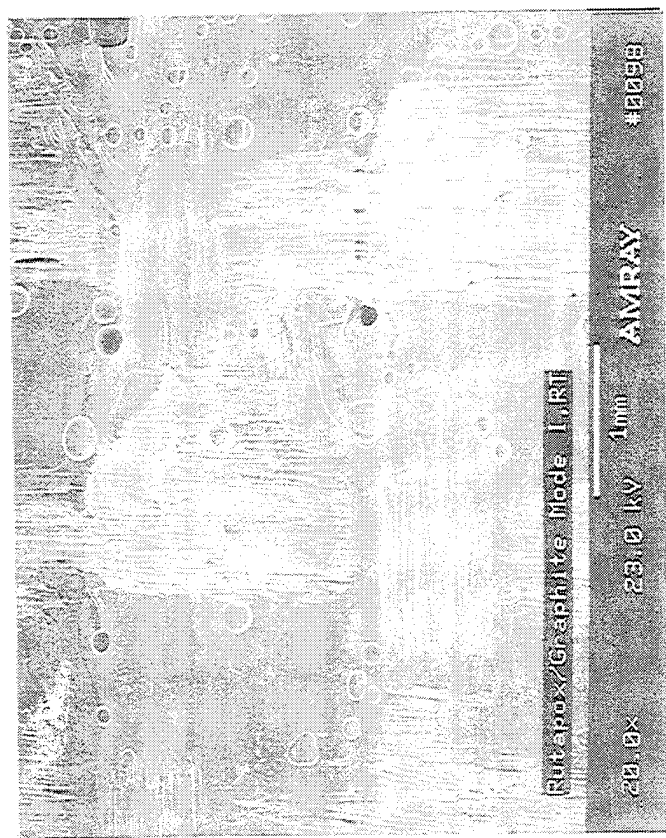
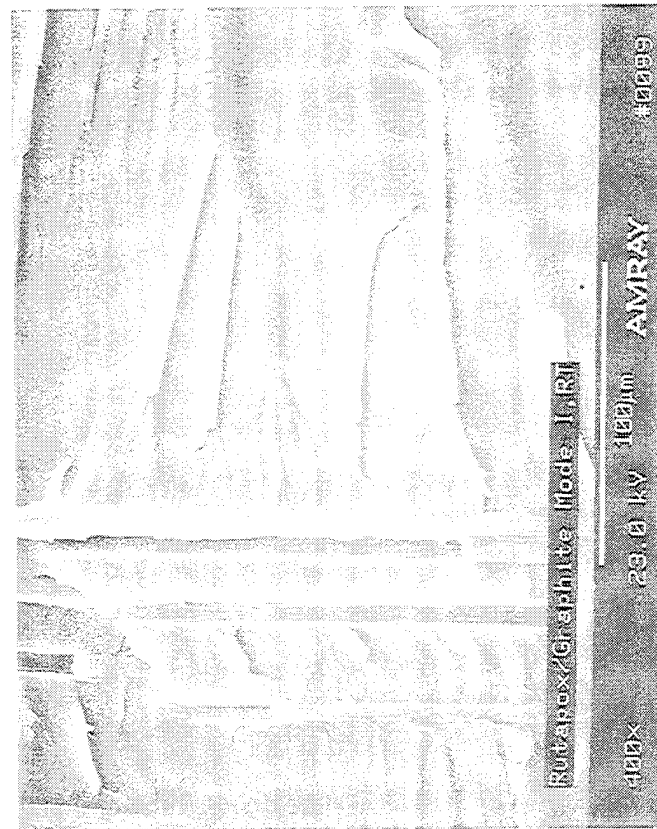
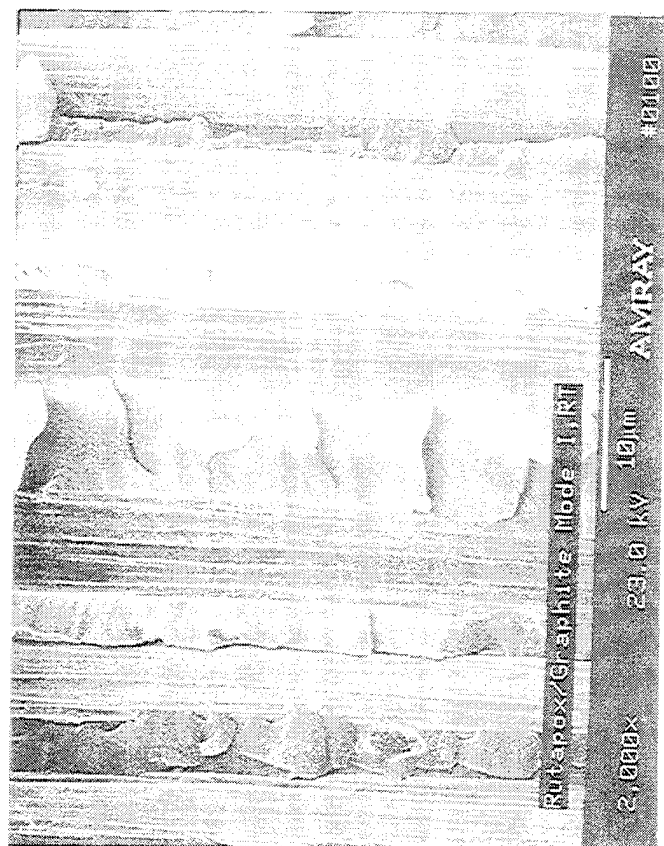
The high strain rate specimen fracture surfaces (Figure 3.7-3 & 3.7-4) were similar to the normal rate specimens, but the river patterns were more evident.

Figure 3.7-4. SEM Fractographs of a Rutapox/Graphite Fabric Interlaminar Mode I (Tensile) High Rate Fracture Surface, RT

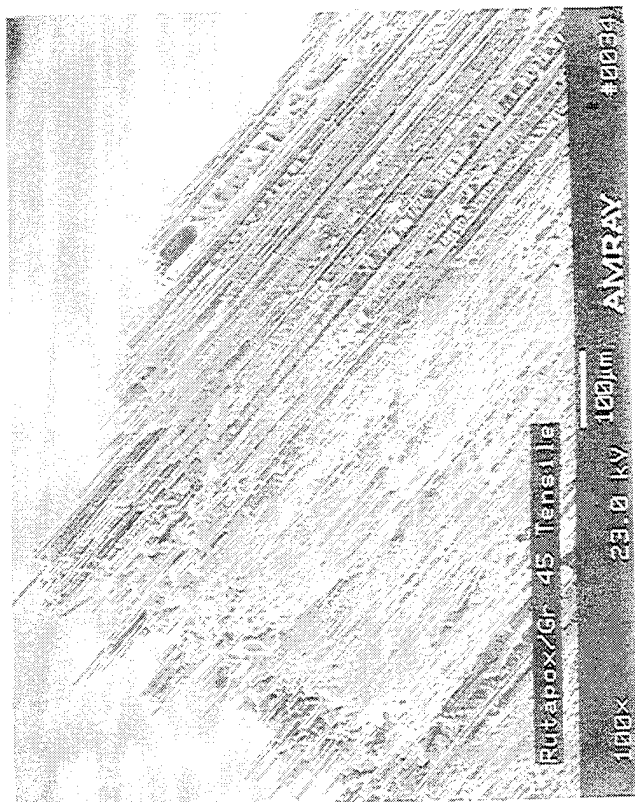
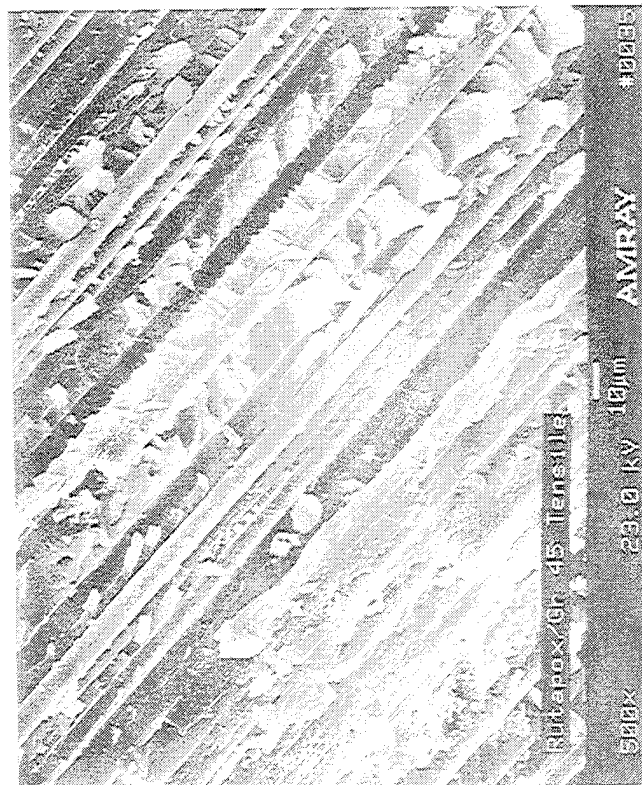
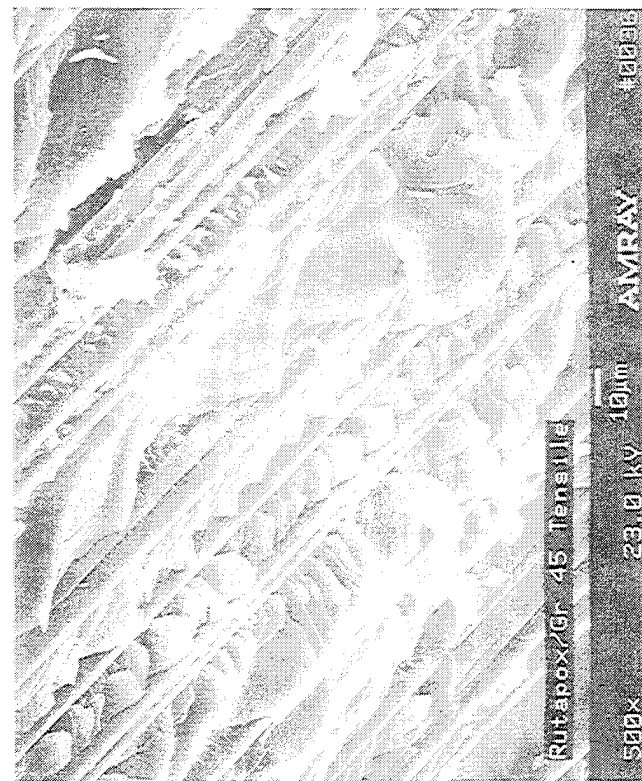
Figure 3.7-9. SEM Fractographs of a Rutapox/Graphite Fabric at 45° Tensile Fracture Surface, RT

The overall appearance of the fabric surface exhibited both mode I and II fractures features (Figure 3.7-9). The orientation of the hackles did not give an obvious indication of the overall crack propagation direction.

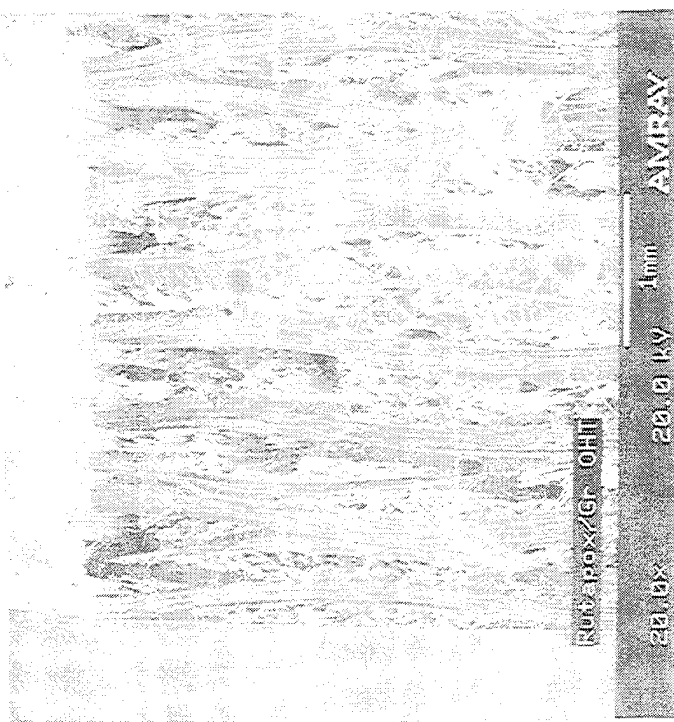
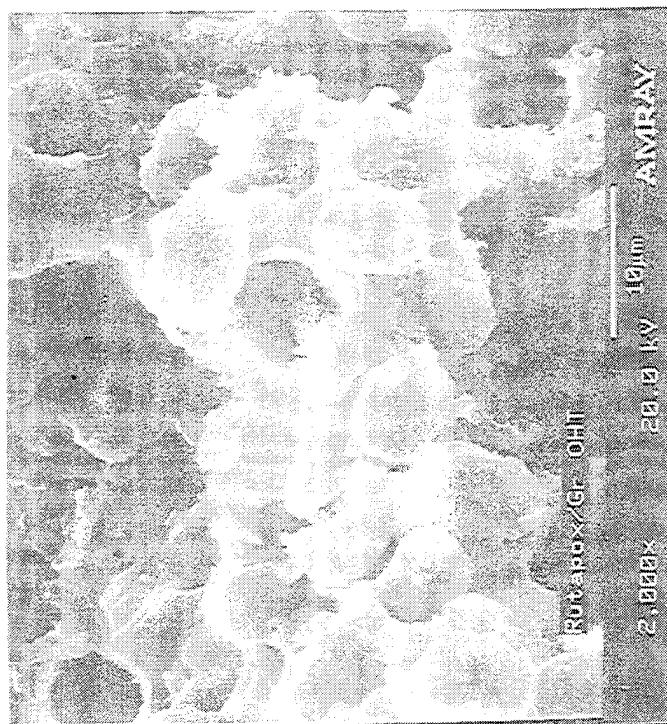
Figure 3.7-10. SEM Fractographs of a Rutapox/Graphite Fabric Open Hole Tension Fracture Surface, RT

The fiber ends did not clearly indicate the overall crack direction from examination of a small sample (Figure 3.7-10). The fibers were oval and contained distinct longitudinal ridges. Tracer yarns in the fabric were clearly visible and were initially confused with some type of fiber pull-out condition. The plies parallel to the crack direction had hackles on the surfaces, but it generally appeared that these tow regions were pulled apart in a mode I.

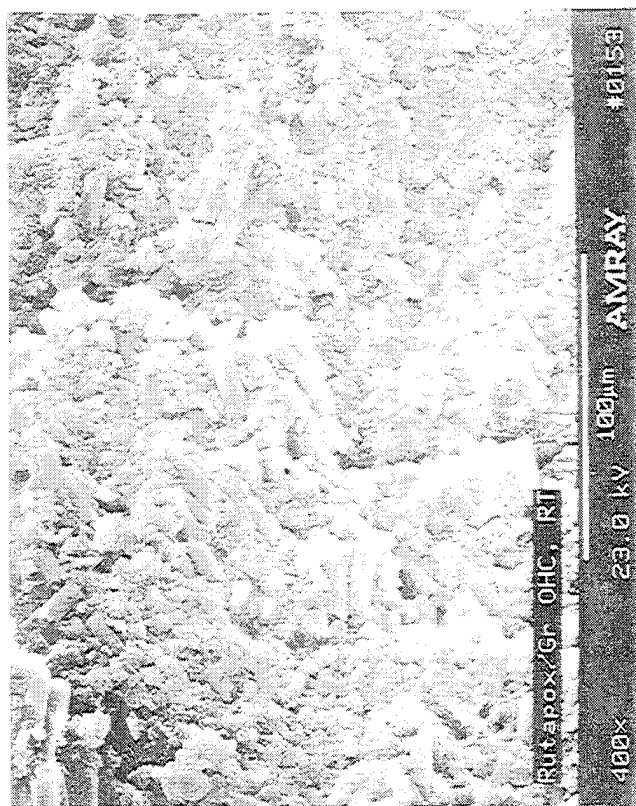
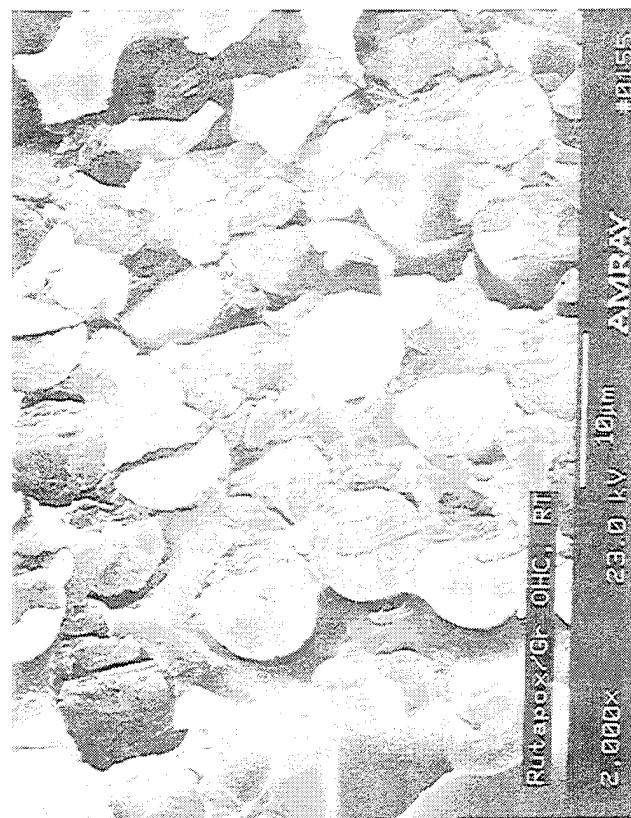
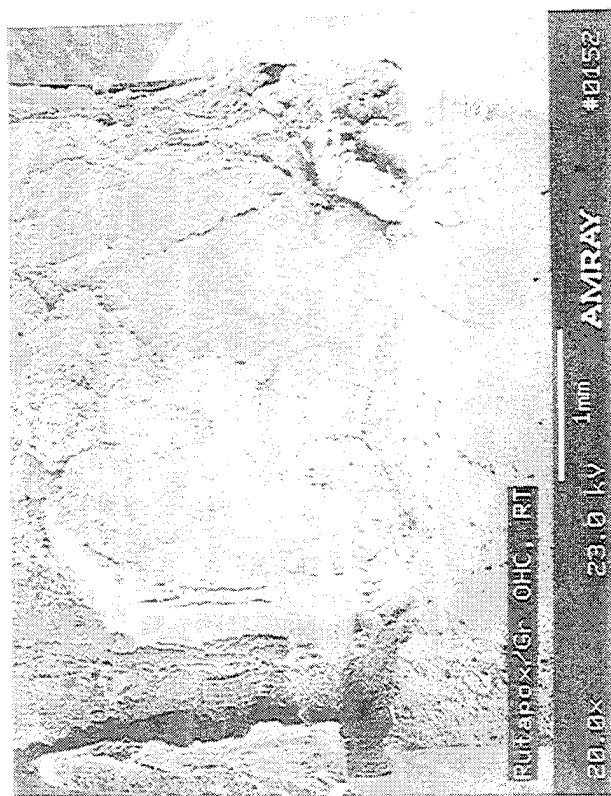
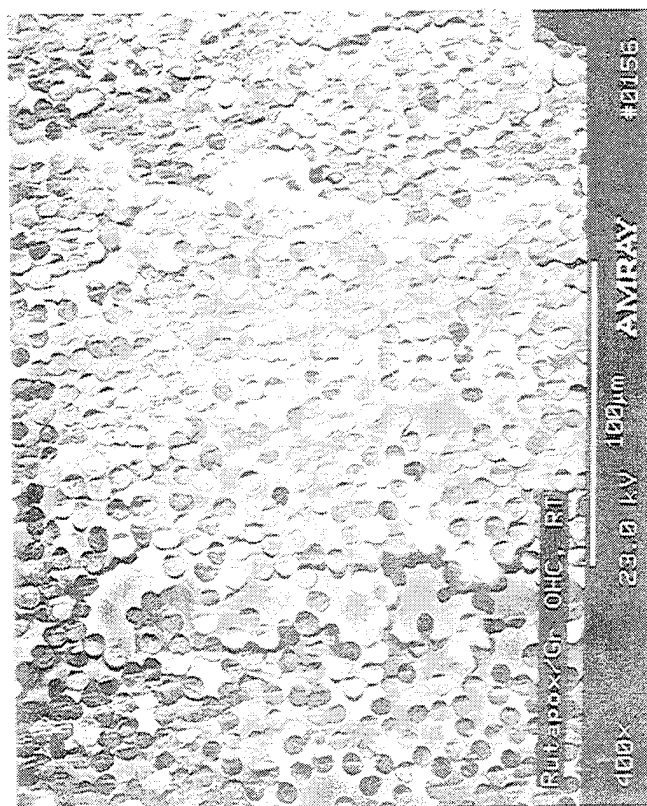
Figure 3.7-11. SEM Fractographs of a Rutapox/Graphite Rovings Open Hole Compression Fracture Surface, RT

Two distinct regions were present on the fracture surfaces (Figure 3.7-11). The region adjacent to the hole contained a great deal of rubble covered with small sections of fractured fibers. The regions further away from the hole exhibited the classic compression fracture morphology with the distinct centerline through the fibers. In addition, some of the fibers were actually split along their centerline to an unknown depth.

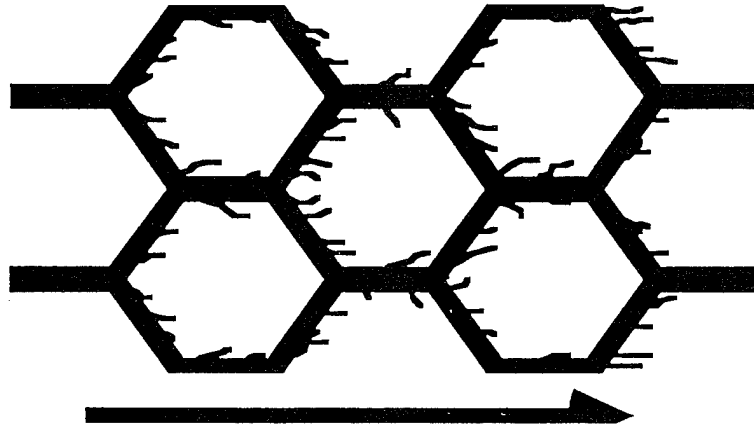
Failure propagation in honeycomb material is best determined by examination of the fiber pullout and by the direction in which the fiber is bent. As the honeycomb fails, the fiber and resin fail separately. The fiber is often freed from the resin by the failure and is drawn plastically in the direction of the displacement due to the propagation of the failure. For tensile failure this displacement is nearly normal to the direction of propagation, with a slight bias in the direction of propagation. The bias can result in plastic deformation of the side of the fiber away from the propagation direction or breakage of the fiber with the propagation direction of the crack in the fiber the same as that in the honeycomb. The result of these effects is that the propagation direction is indicated by the lay of the loose ends of fibers along the failed surface (see Figure 3.8-1). Studying the crack propagation directions in the resin meniscus where the honeycomb ribbons join is a more difficult method of determining the failure propagation direction.

Figure 3.8-1. *Fibers Torn and Bent in the Direction of the Propagation of the Failure*

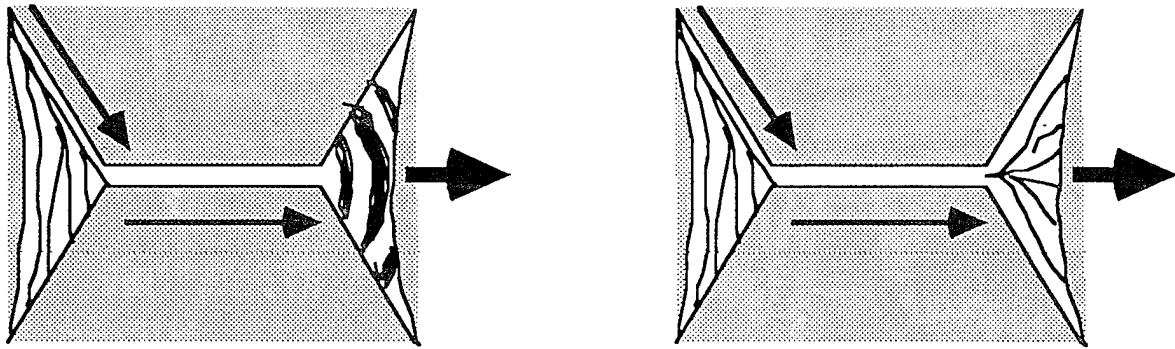
Figure 3.8-4. Failure Patterns in the Resin Menisci Indicating the Propagation Directions

The illustration on the left shows "Wallner" lines indicating the failure initiated at the apex of the upper arm of the meniscus. It then propagated across the joint and caused a conchoidal fracture in the trailing meniscus. The illustration on the right shows the same type of event but with a Wallner line failure pattern at the trailing meniscus.

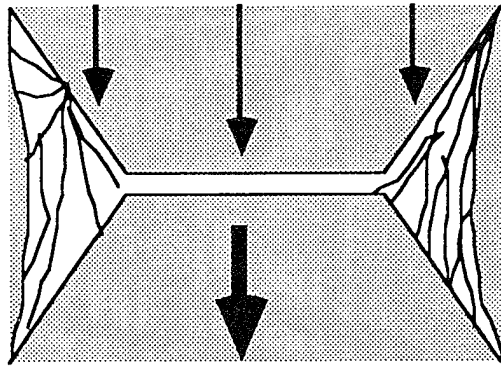
Figure 3.8-6. The Wallner Line Pattern for a Failure Propagating Normal to the Ribbon Direction

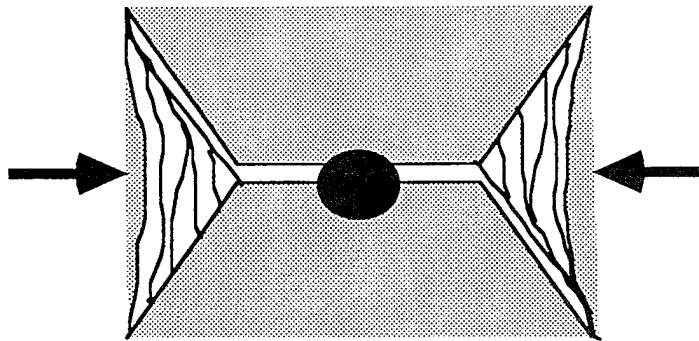
Figure 3.8-7. The Wallner Line Pattern for a Failure Propagating Inward From Both Sides Indicating a Vertical or Twisting Failure

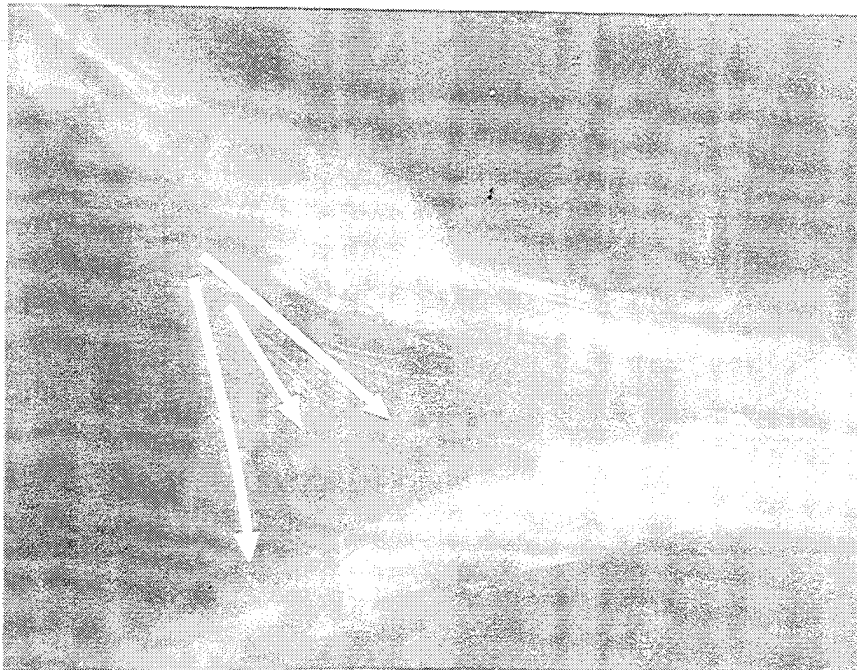
Figure 3.8-9. Optical Fractographs of Mode I Sandwich, Control Specimen  
Sheet 1 of 2

**Control Specimen.** No adhesive or cohesive failures were seen in these specimen types. As shown in Figure 3.8-9, 100% core failure was observed.

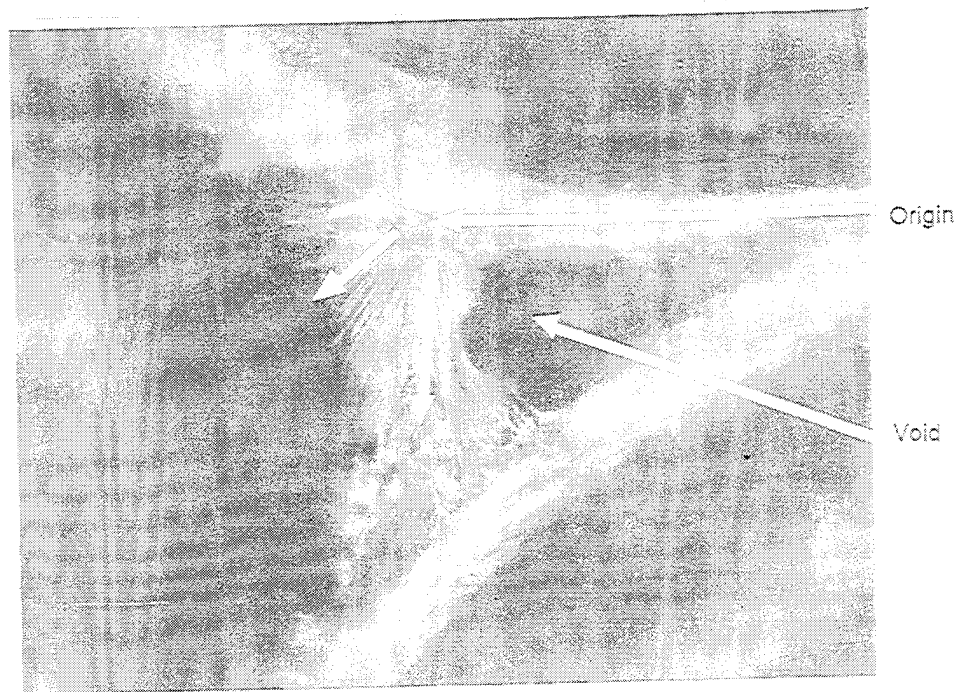
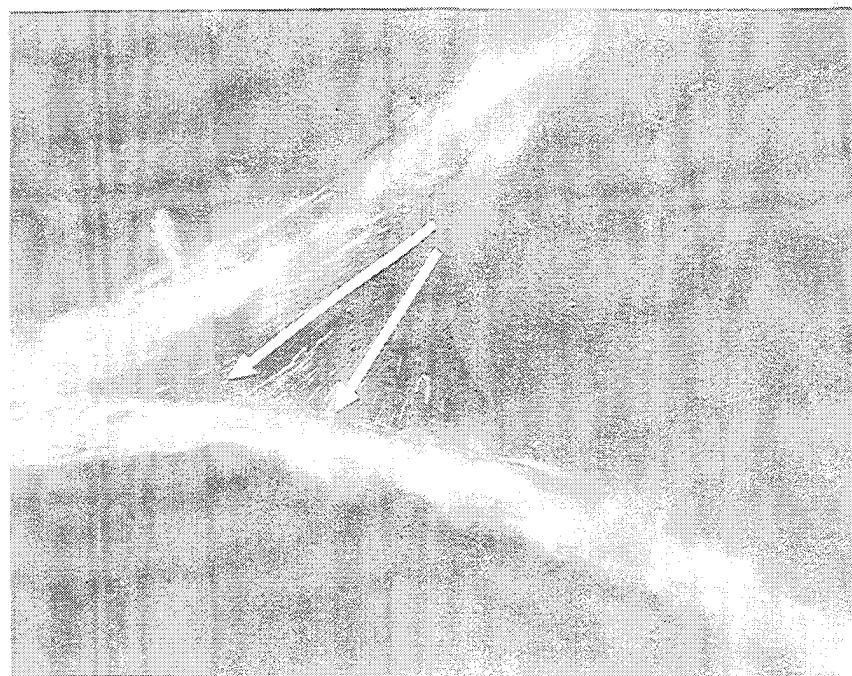
Figure 3.8-10. Optical Fractographs of Mode I Sandwich, Aged Adhesive Specimen  
Sheet 1 of 2

**Aged Adhesive Specimen.** The honeycomb cells appeared to be more distorted in these specimens than in the others. It has not been determined if this is the result of processing or testing. The amount of burst fibers was less than that seen in the control specimen. As shown in Figure 3.8-10, the failure was in the honeycomb.

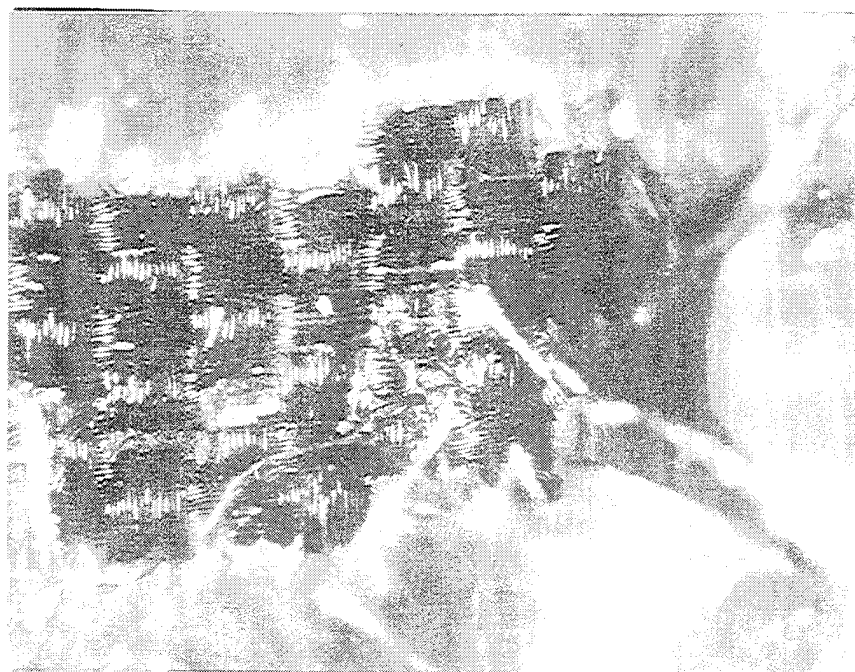
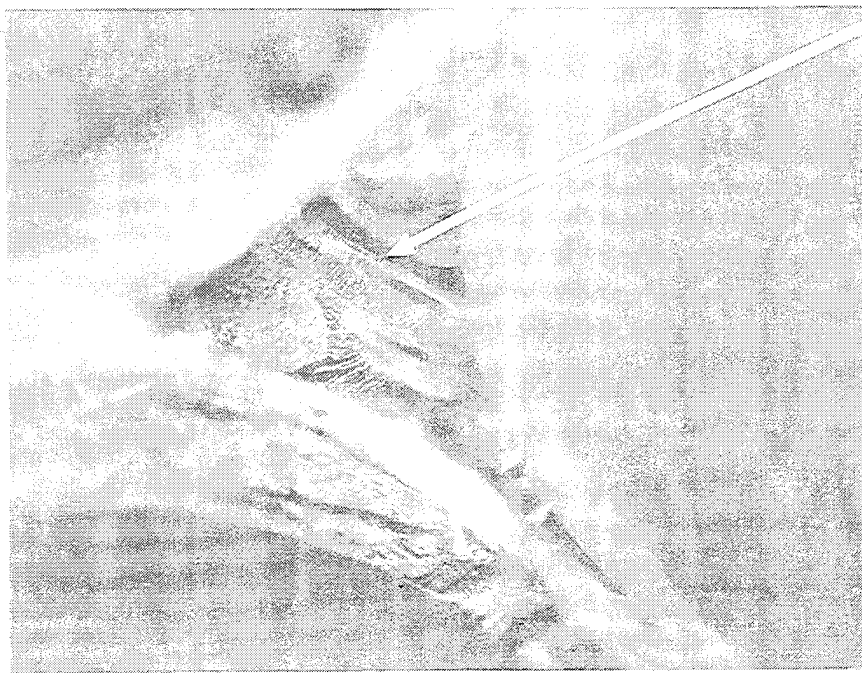
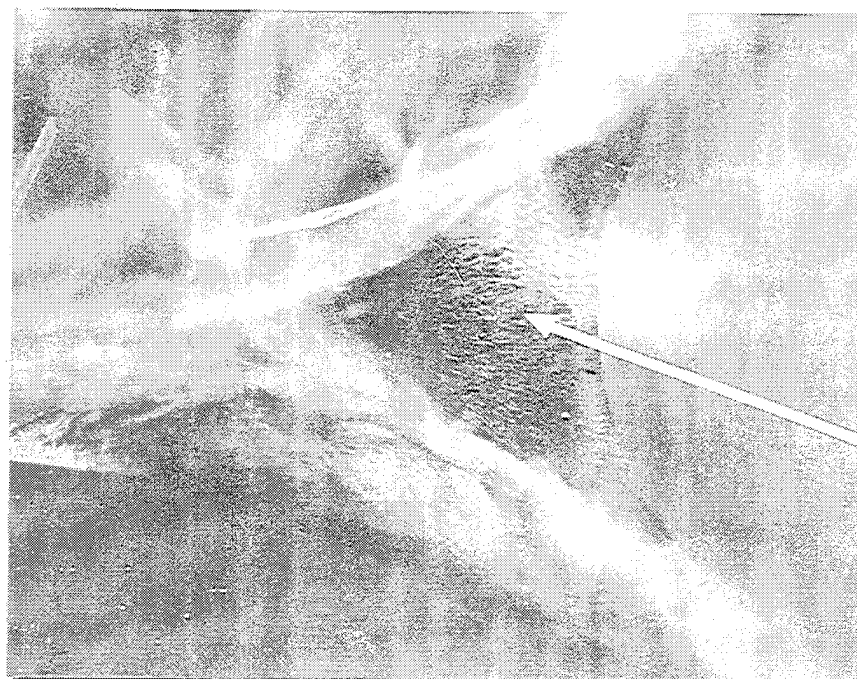
Figure 3.8-11. Optical Fractographs of Mode I Sandwich, Stronger Core Used (8-lb) Specimen  
Sheet 1 of 2

**Eight-Pound Core Specimen.** The failure occurred primarily in the adhesive layer. Both adhesive and cohesive failure was evident. The adhesive failure, between the adhesive and the face sheet, occurred near the center of the specimen. Approximately 25% of the core failure was observed in these specimens. Optical fractographs taken at 200X showed a lower velocity fracture characteristic as evidenced by the mirror and mist fracture features shown in Figure 3.8-11.

Wallner  
lines

Mist

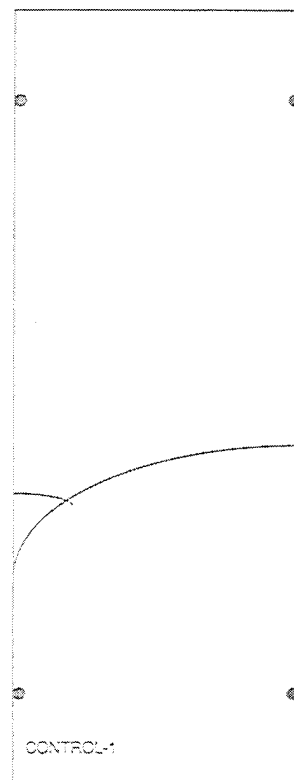
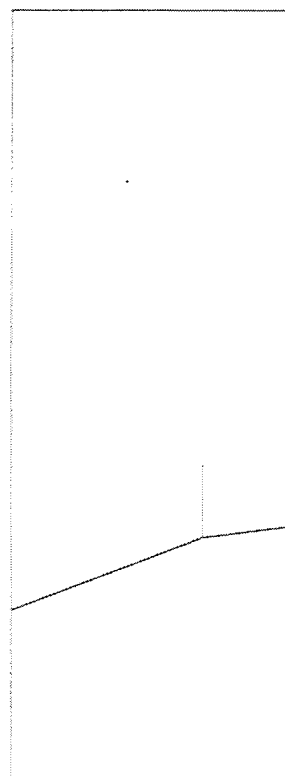
Figure 3.8-16. Control Sample 1—2.4X Reduction

The crack pattern in the honeycomb is illustrated in the edge view drawings. The alternating light and dark vertical bands signify individual cell walls of the honeycomb; walls normal to the edge are now shown. The lines indicate visible cracks in the honeycomb walls, and the thickened surface sheets indicate delamination of the carbon fiber/resin composite, cohesive failure of the adhesive, adhesive failure of the adhesive, or honeycomb fracture at the adhesive meniscus. The type of failure at that surface is identified in Figure 3.8-15. Figures 3.8-16 through 3.8-30 show the specimens and the crack diagrams.

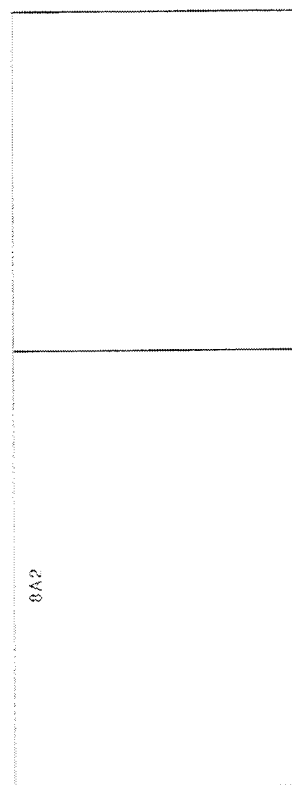
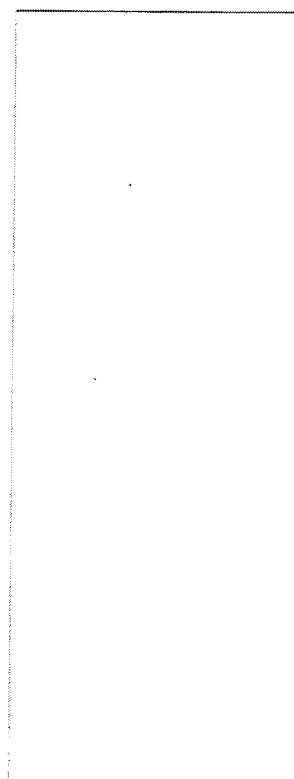
Figure 3.8-26. Undercured Adhesive Sample 8A2—2.4X Reduction

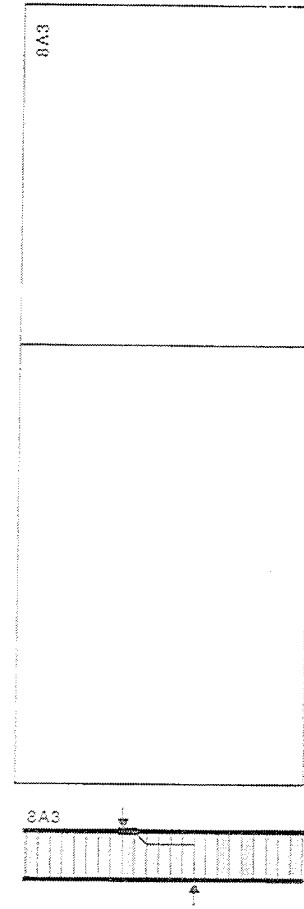
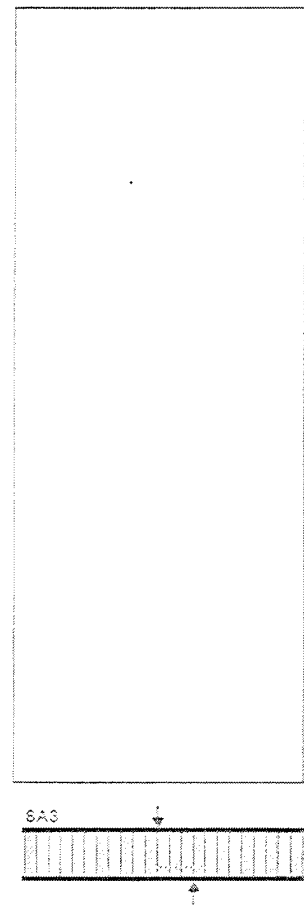
Figure 3.8-27. Undercured Adhesive Sample 8A3—2.4X Reduction
